DRAFT REMEDIAL INVESTIGATION WORK PLAN FOR THE CARSTADT FACILITY CARLSTADT, NEW JERSEY

DIAMOND SHAMROCK CHEMICAL COMPANY Environmental Safety Services 1149 Ellsworth Drive Pasadena, Texas 77501-1000

Woodward-Clyde Consultants 201 Willowbrook Boulevard Wayne, New Jersey 07470 (201) 785-0700

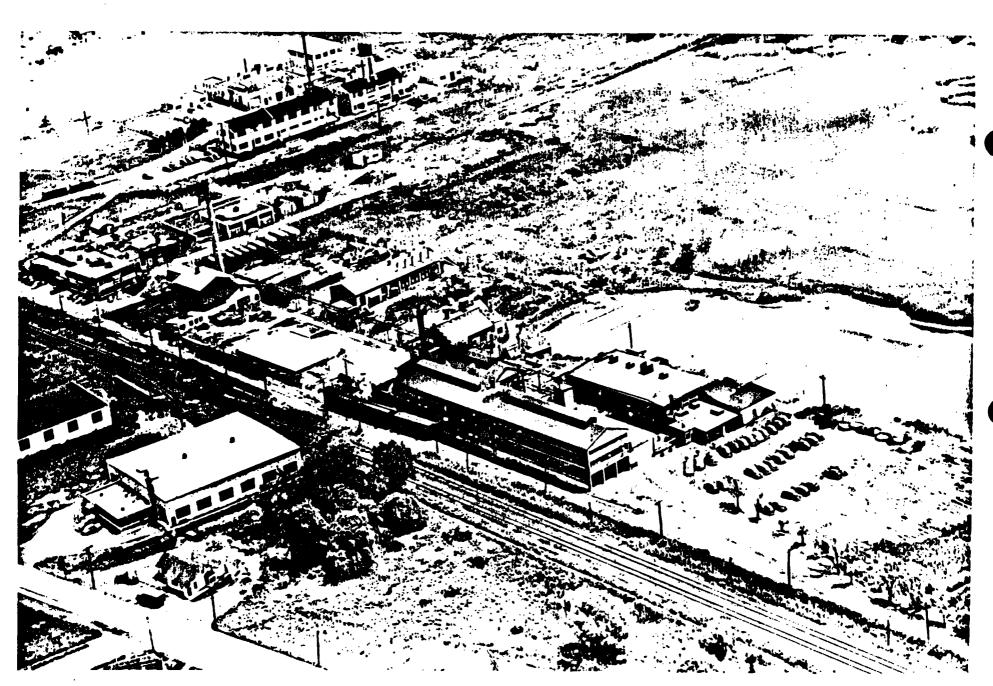
Plate 2-1

An aerial photograph (Plate 2-1) shows the site during the 1940's before construction of building B12, the plant office building and the spray tower, a large cylindrical

structure partially completed in Plate 2-2. Smaller cylindrical vessels are seen under construction in Plate 2-2, adjacent to building B1, now an enclosed area. Plate 2-2 probably was made in the late 1940's or early 1950's before the pond road and tank farm were constructed. Near the center of the photographs (also Plate 2-1), a white rectangular area was used for off-loading sulfur from rail cars. The area is enclosed at present. Numerous other changes have occurred since the 1940's but the basic plant layout remains the same.
